TRE17 150-mm Secretan Reflector: Restoration

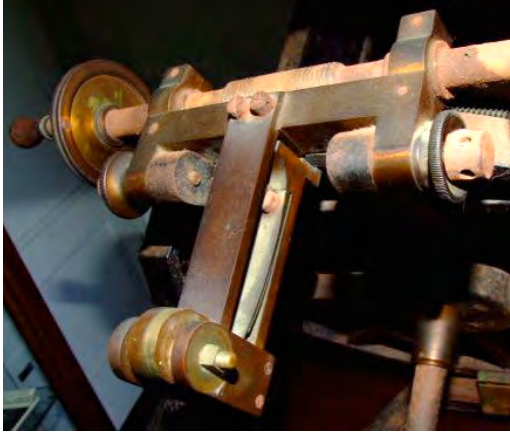
Replaced missing lever and keeper nut (twist tab on main tube lid was used for designing shape of lever)

1. Carefully cleaned rusted iron parts and repainted with satin black enamel
Brass parts were cleaned by not down to bare brass - all tooling marks were left
2. I was fortunate to find an eyepiece replacement that works just fine.
3. Designed a new engaging lever and keeper nut (see photos) - used retainer flanges on inside of the end cap as a design guide for the lever.

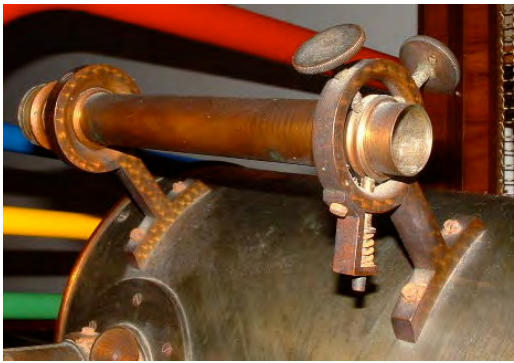
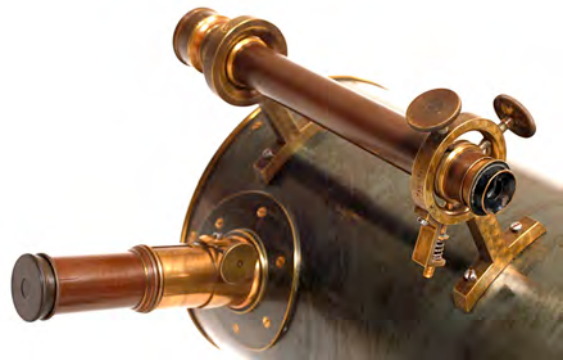
Replaced missing eyepiece in finder scope

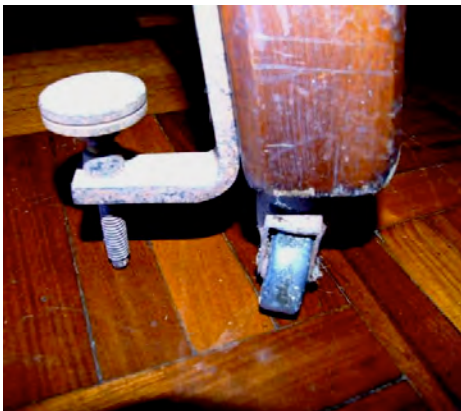
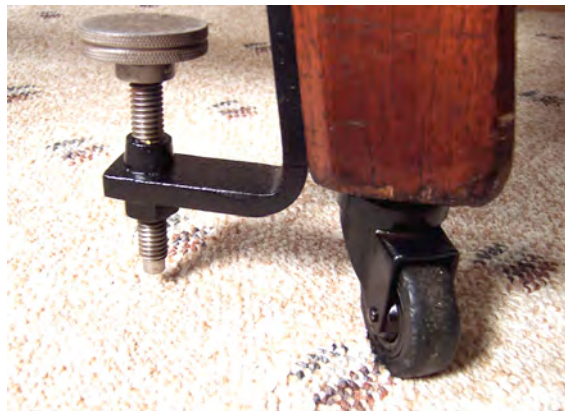
Straightened, cleaned and repainted with black satin enamel

Before

After

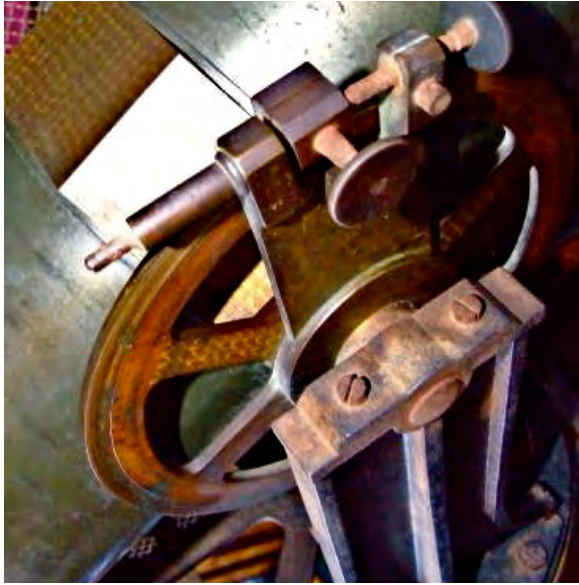
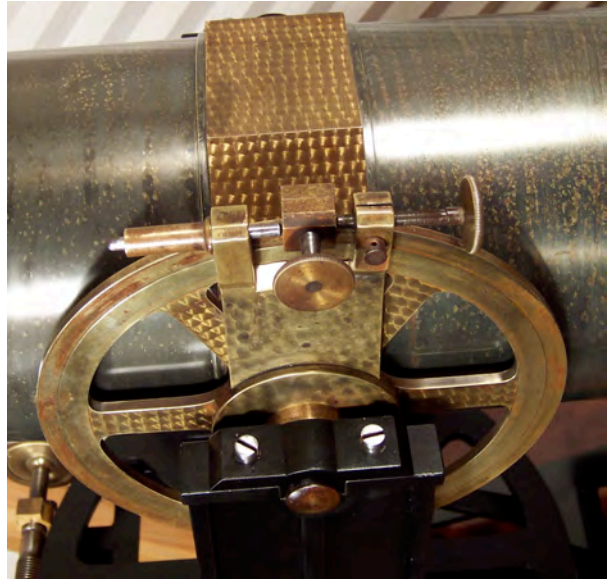
Declination adjuster and setting circle

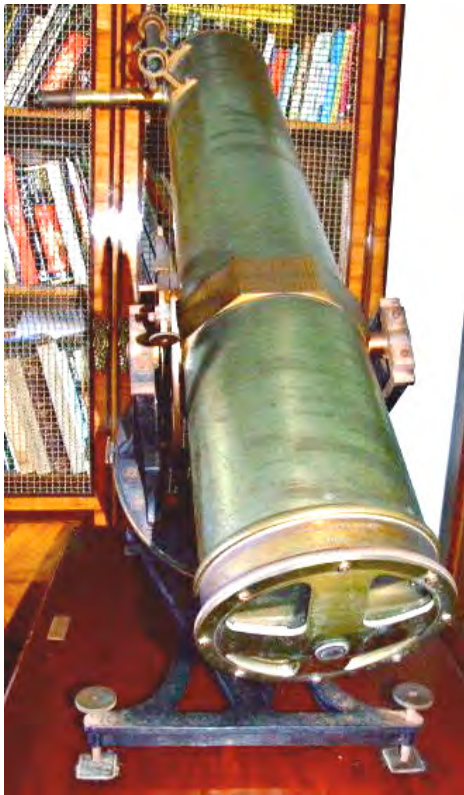
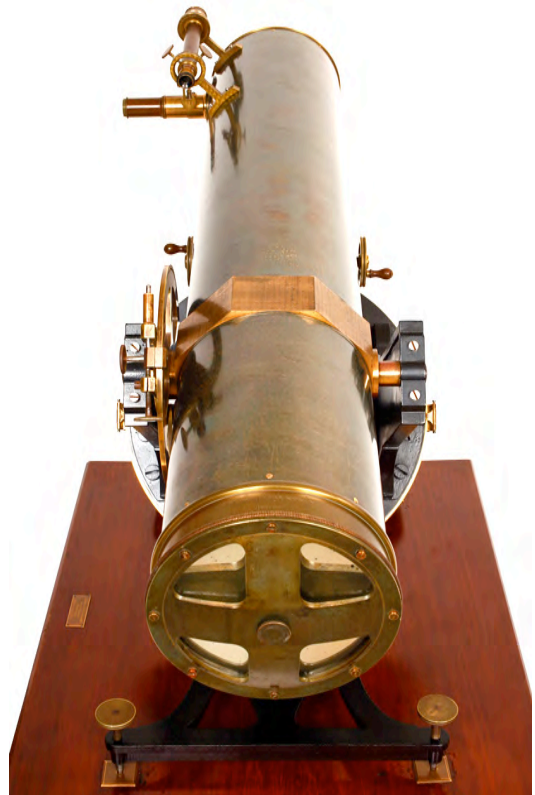
Before

After

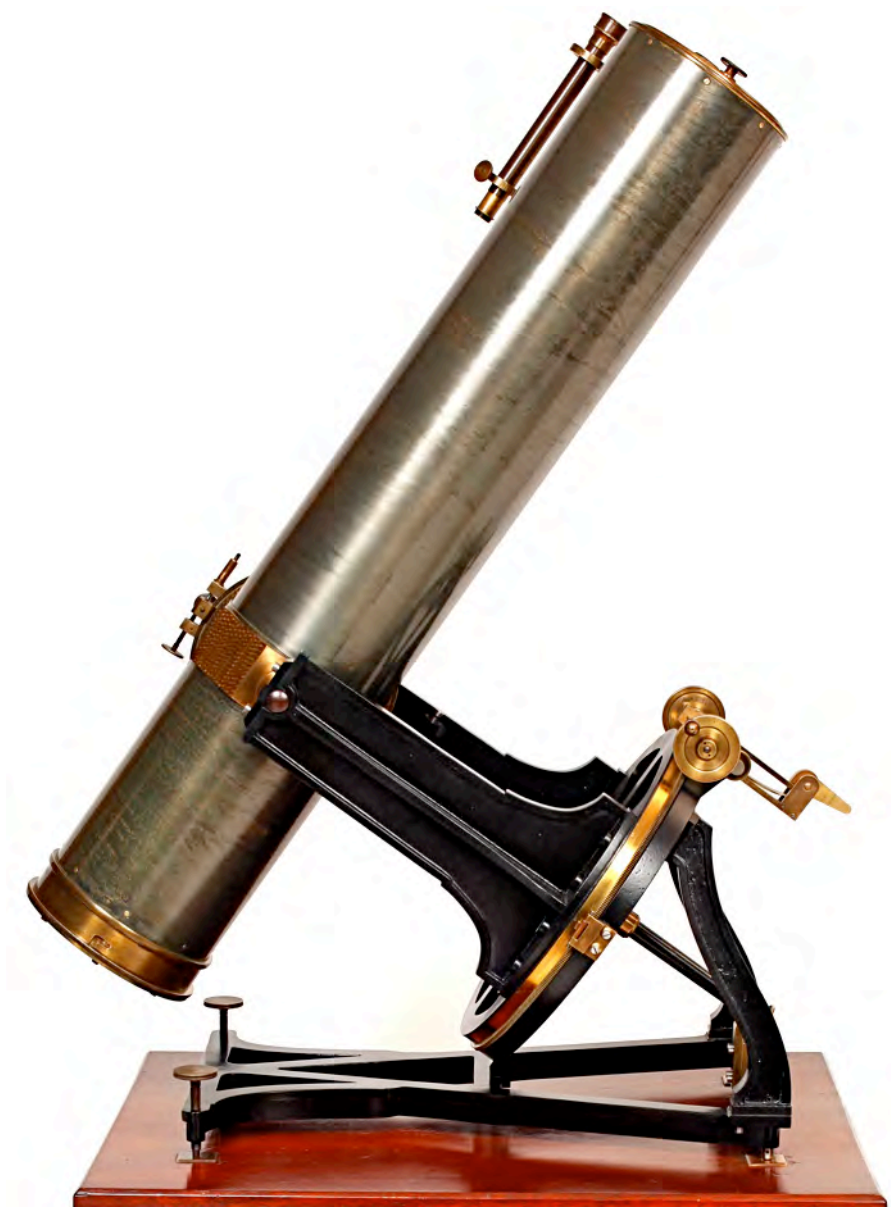
Restored
